Project Summary

Cost-effective Leak Identification using WaterGEMS

Maynilad Uses Hydraulic Modeling to Pinpoint Hard-to-find Leaks and Increase Service Level

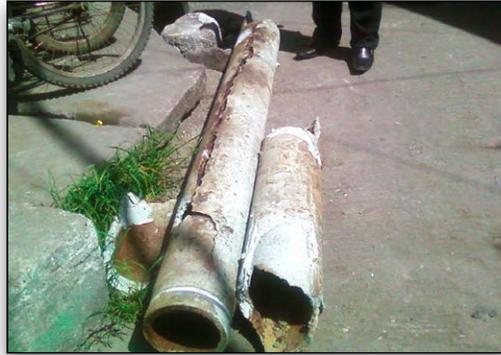
The cause of the leak is on this 200 millimeter pipe.

With the WaterGEMS study, a leak was pinpointed in the location indicated by the model. Upon excavation, it was discovered that an entire six-linear-meter section of the 200 millimeter asbestos cement pipe was busted longitudinally, causing the huge pressure drop in the area.

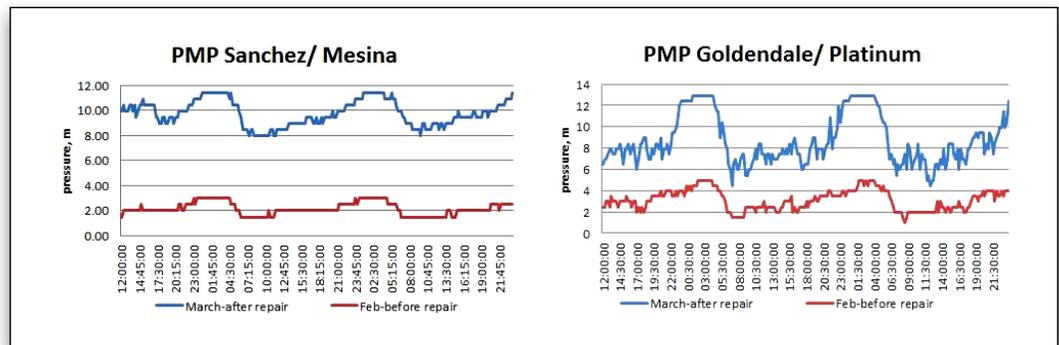
Pressure increase at critical points after the repair.

The leak repair contributed a very significant increase in pressure by 6 meters (8.6 psi) and billed volume by 200 cubic

meters per day (0.2 MLD). It also reduced NRW by almost 1900 cubic meters (1.9 MLD).
